Reduction of Longitudinal Crack in Beam Blank Casting

SYS Smart Surface

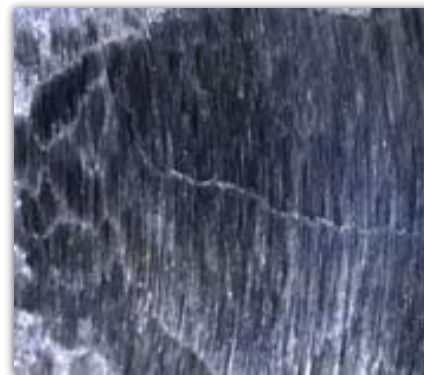
Beam Blank

Depth of Longitudinal crack 2mm

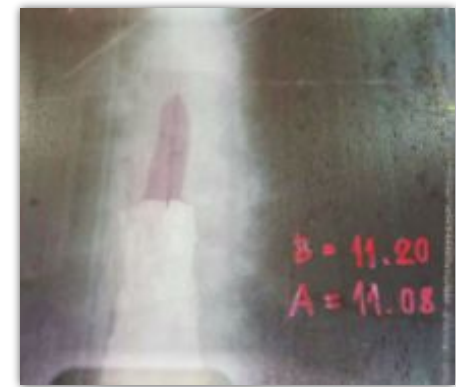
H Beam

Depth of Longitudinal crack 0.5mm

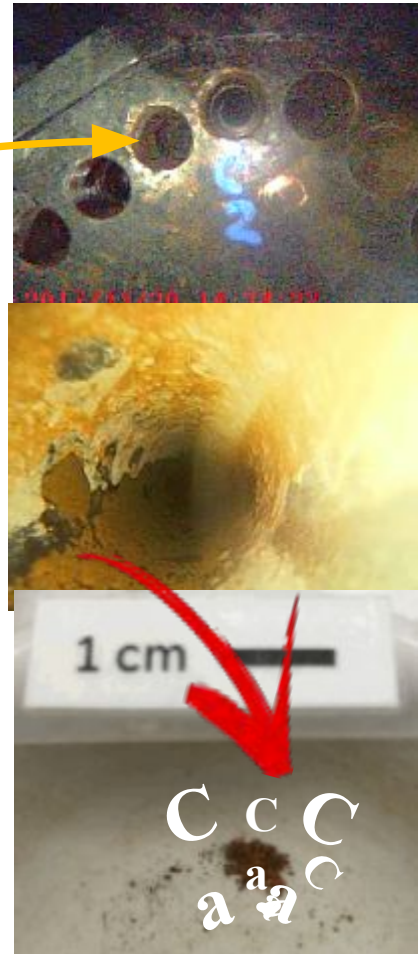
The thermal conductivity of Ca Scale is about **1/300** compare to Cu

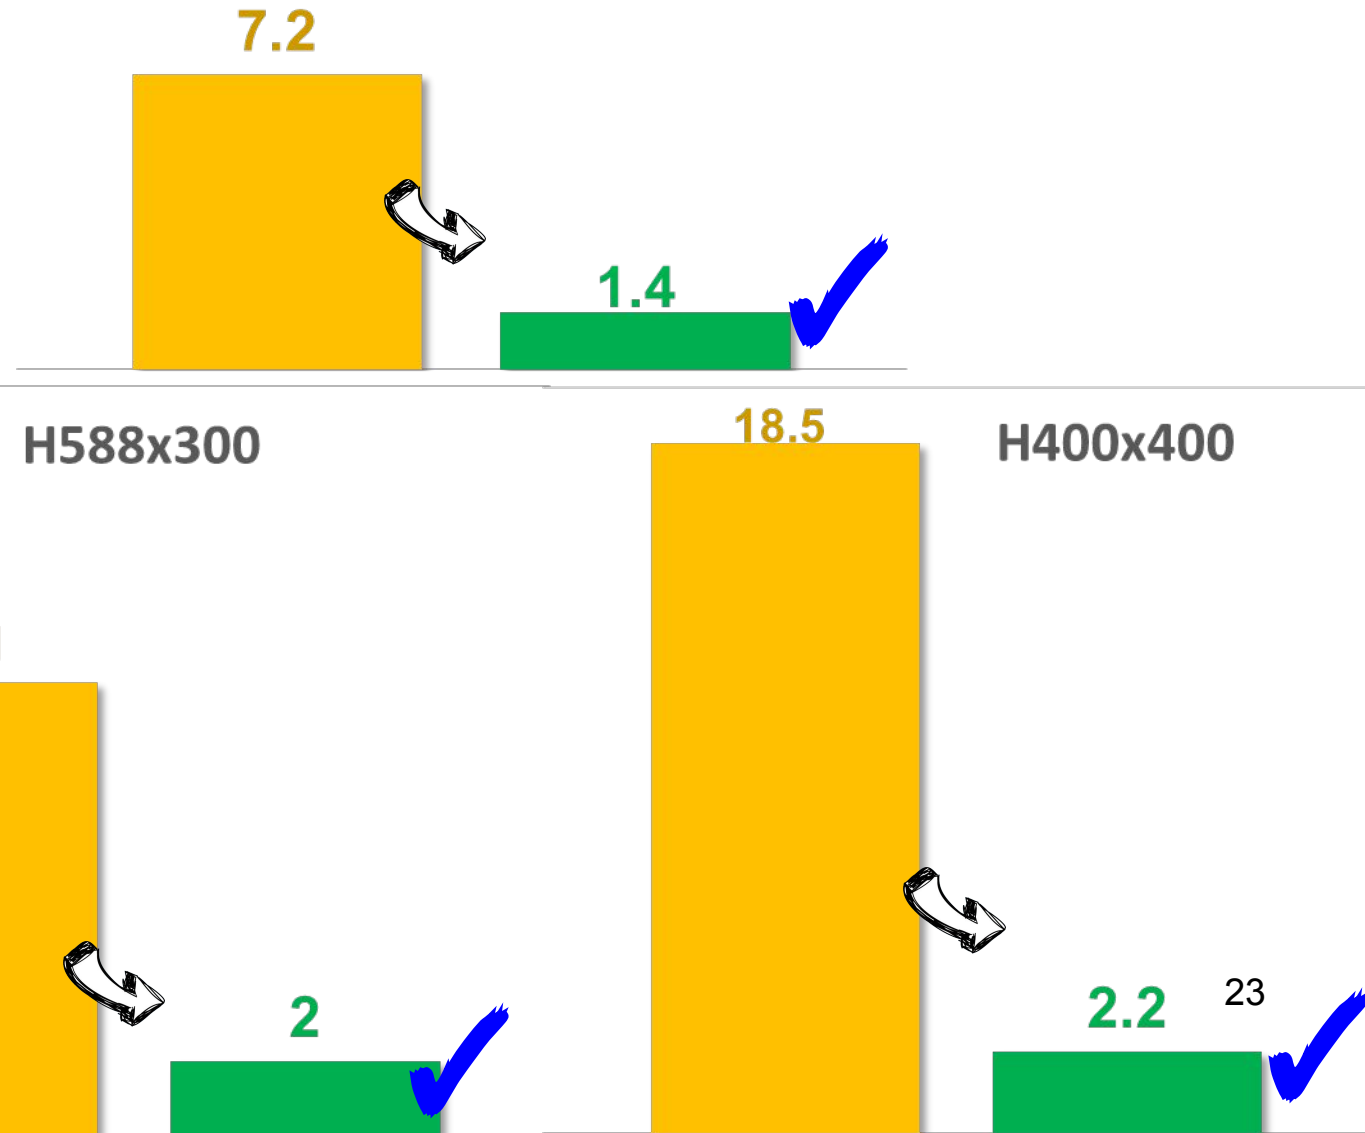
Result of Actual control & % Longitudinal Crack

Control standard	Actual
Fp value	≤0.85	0.79 – 0.85
Mold cleaning	≤250 Heat	198 Heat
Ca-Hardness	≤10 ppm	3 ppm
Foot roll spray	35 – 39 L/min	32 – 36 L/min
Spray side C	37 – 43 L/min	35 – 40 L/min
