Improvement of Corner Cracks in Slab Continuous Casting for Peritectic Steel by Chamfered Mold Technology

Hsing Yu SUN
Engineer, China Steel Corp.

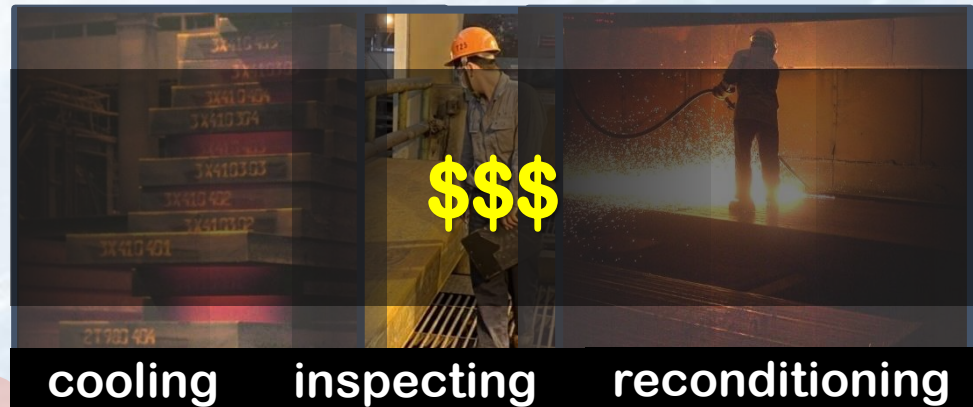
The quality assurance cost for potentially slab transversal crack

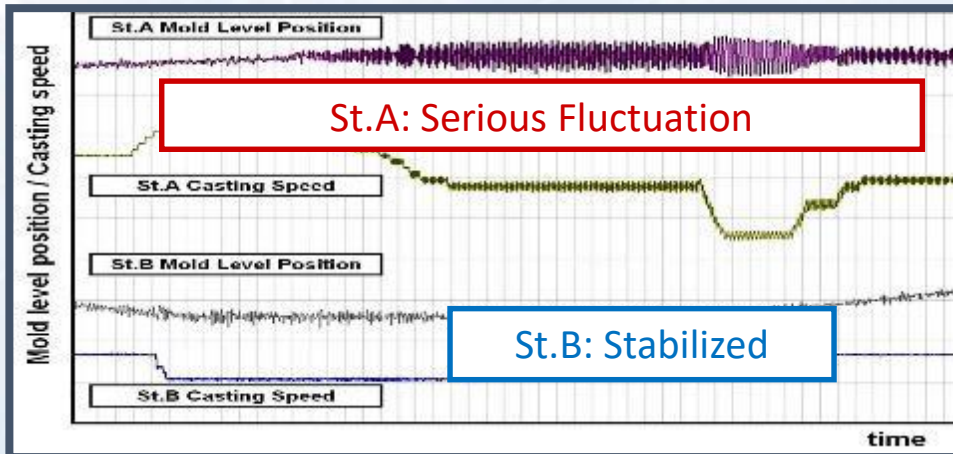
Mold level with different hydraulic pressure

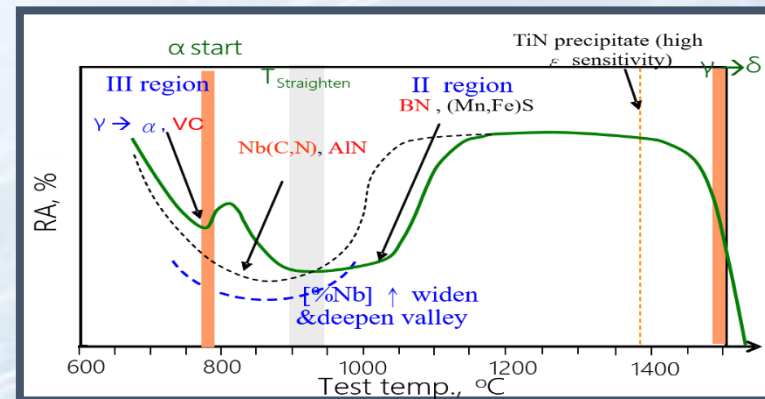
- Using soft cooling casting powder(high basicity).

- To increase the temperature when unbending.
- Modifying the 2nd cooling design, ex: spray pattern, specific water capacity...etc.

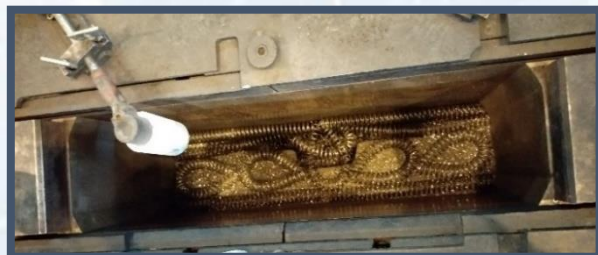
- Type: Vertical-Bending
- Dimension: 250 mm*(950~1575) mm
- Metallurgical Length: 37.2 m
- Casting Speed: 1.0~1.4m/min
- Products: low carbon & peritectic steel for hot rolling, tin plate...etc.
- Chamfered mold design target: transversal crack
- Mold figures: multi-phase, and modified foot-roller, large chamfered face

Photo of #5SCC caster and chamfered mold

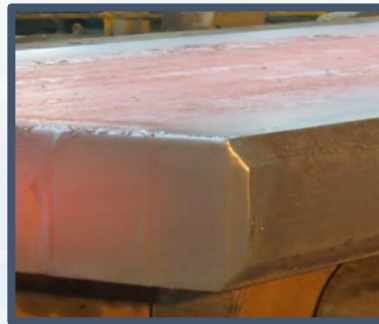
Chamfered slab
 $\sim 818^{\circ}\text{C}$ (IR Sensor)

- Temperature increased ~ 60 °C.
- Transversal crack rate was reduced by 33%.

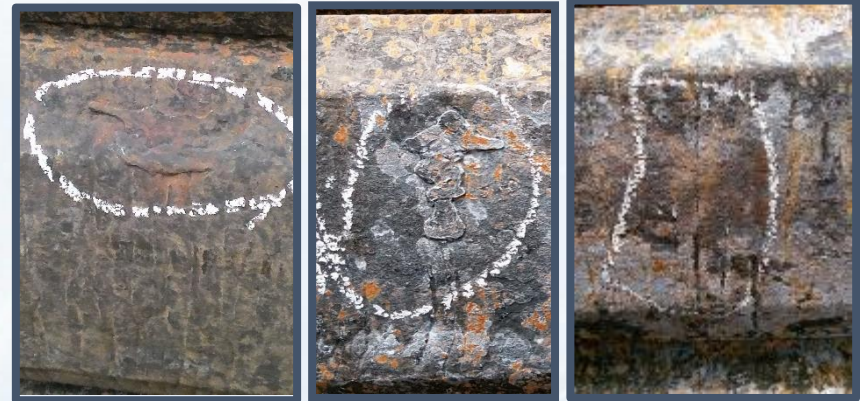
- parallel to oscillation mark, leaking out and quick repaired.
- without breaking out, messy sticking casting powder, and sticking point.
- Considering the support would be insufficient at upper mold area.
- Improved by increasing taper ratio~0.01%.

Photo of bleeding on chamfered slab
