SEAISI Steel Mega Event & Expo
(Technology, Sustainability, Construction)

Upgrade Rolling Mill No.1 Laying Head Machine

Company: Southern Steel Berhad

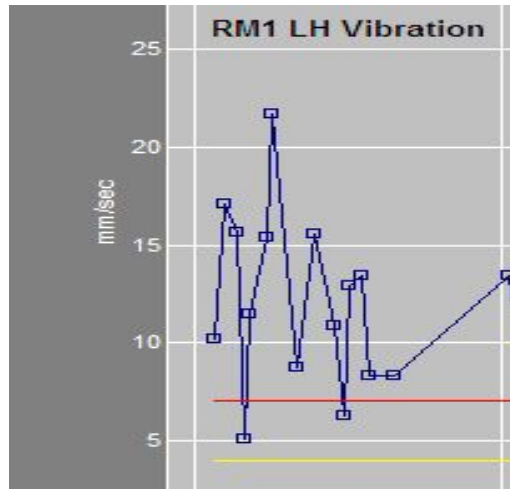
High vibration >19.0 mm/s

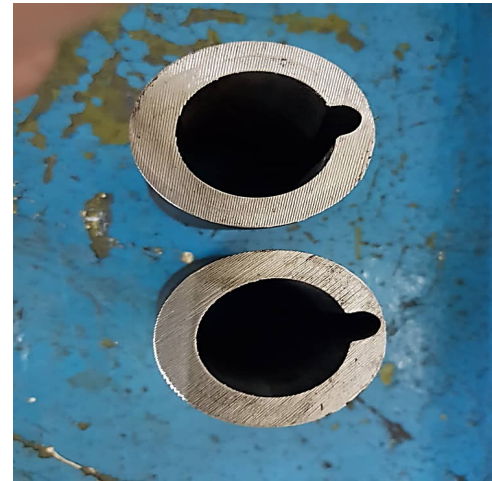
Laying head pipe fast wear-off

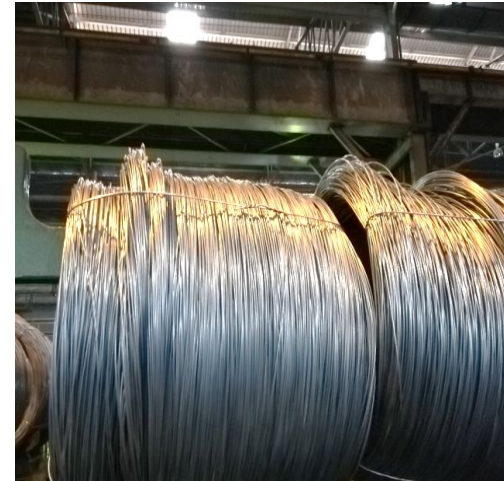
Coil Shape Problem

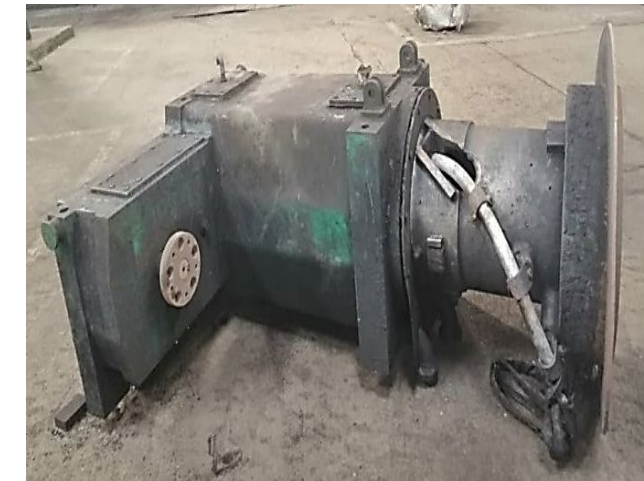
Closure Type Gearbox Structure

1. Production Breakdown for checking on high vibration level
2. Laying Head pipe wear-off with low production tonnage
3. Wire rod coil out of shape
4. Gearbox structure not ease for maintenance
 - Time consume for gearbox overhaul work
 - Unsafe for remove the rotor shaft

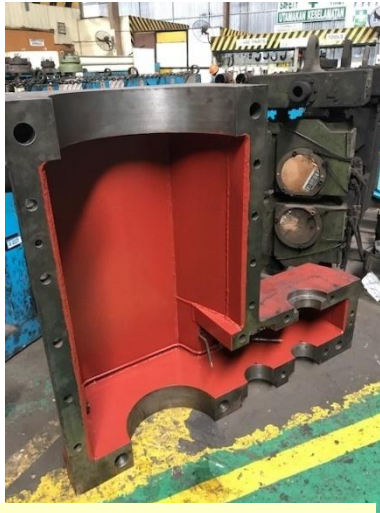
CLEANING OF GEARBOX CASING

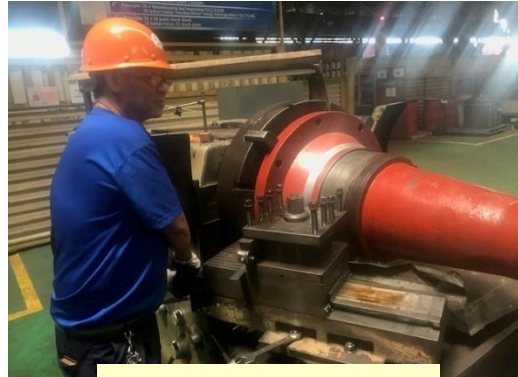
MACHINING OF ROTOR SHAFT

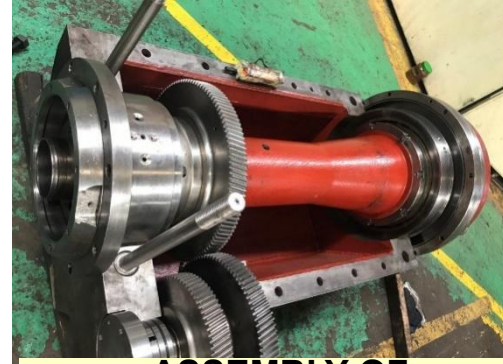
ASSEMBLY OF BEARINGS, GEARS & ROTOR SHAFT

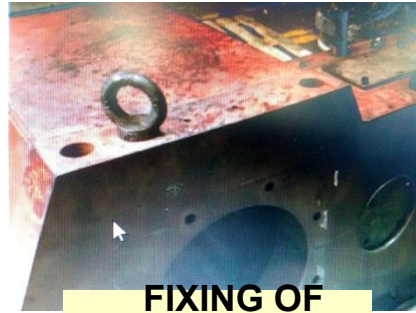
FIXING OF CASING COVER

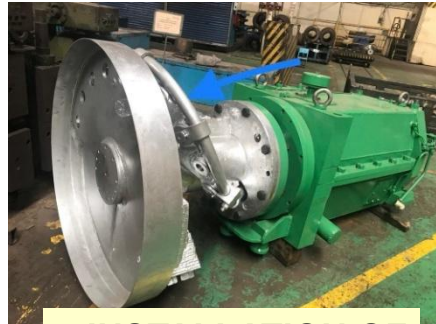
INSTALLATION OF ROTOR WITH PIPE

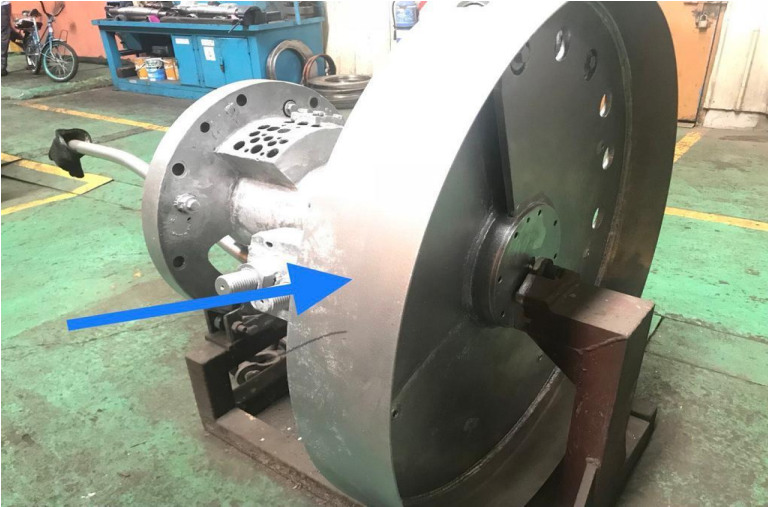
**Add in pressurized air
line to remove
accumulated scale in
Laying Head pipe**

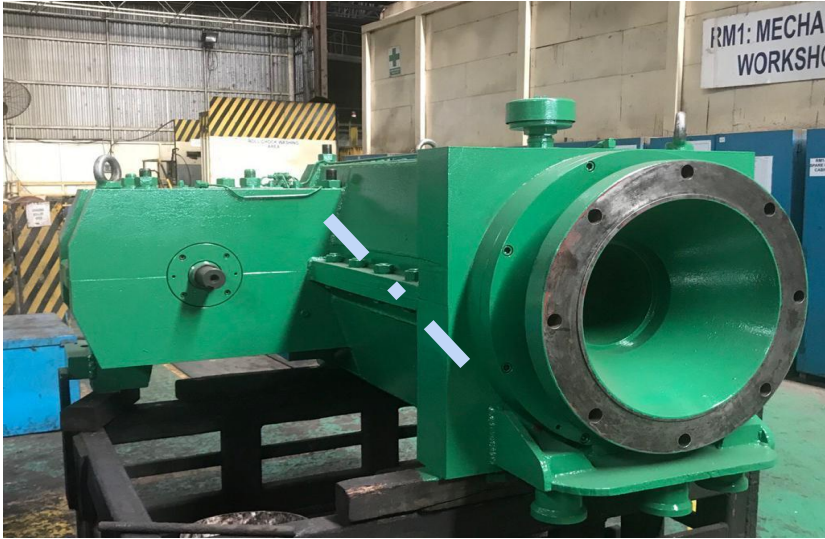
**Open Top Gearbox Structure
Ease for maintenance
Save time to remove rotor & gear
Safe on overhauling**

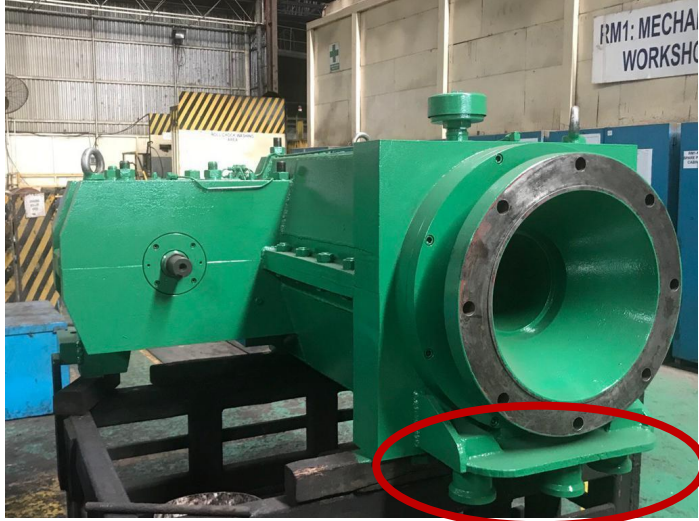
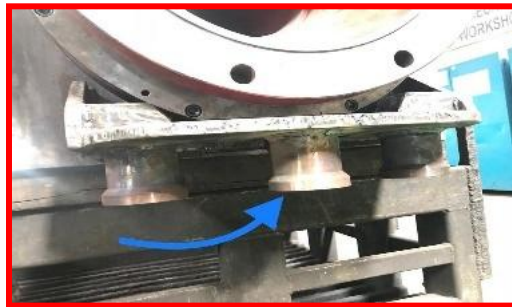
**Slot in
Lubrication Pipe
Save time
Less work**

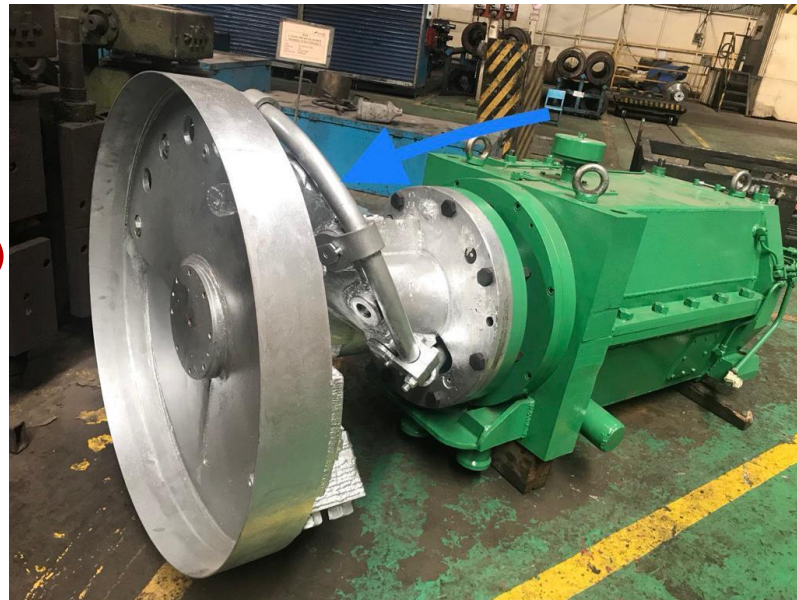
**Isolate Gearbox structure
from Rotor for easy maintenance**

**Common Spare Part on
Rotor & Gear wheel
with Rolling Mill No. 2**

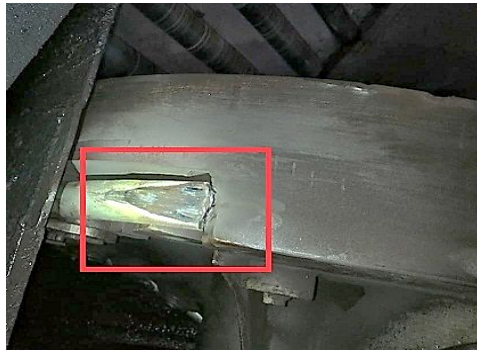
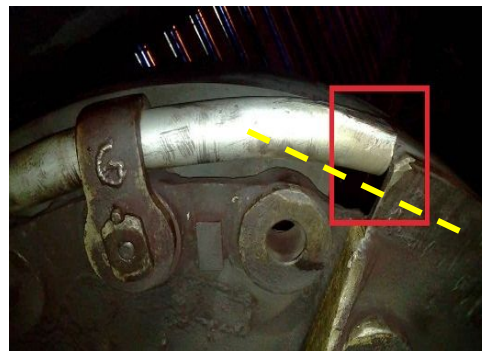
Rolling Mill No. 1 New Laying Head Machine Abnormal Sound & High Vibration

- Laying head pipe ejected from origin
- Generate abnormal sound during operation

Kaizen : Add guide plate 50 mm to hold the Laying Head pipe.

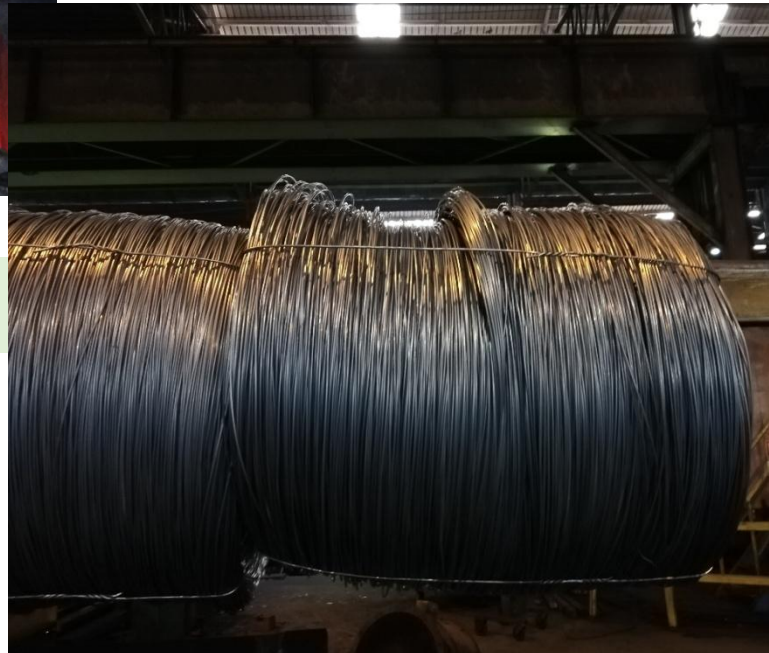
Old Laying Head Machine

Bad Coil Shaped

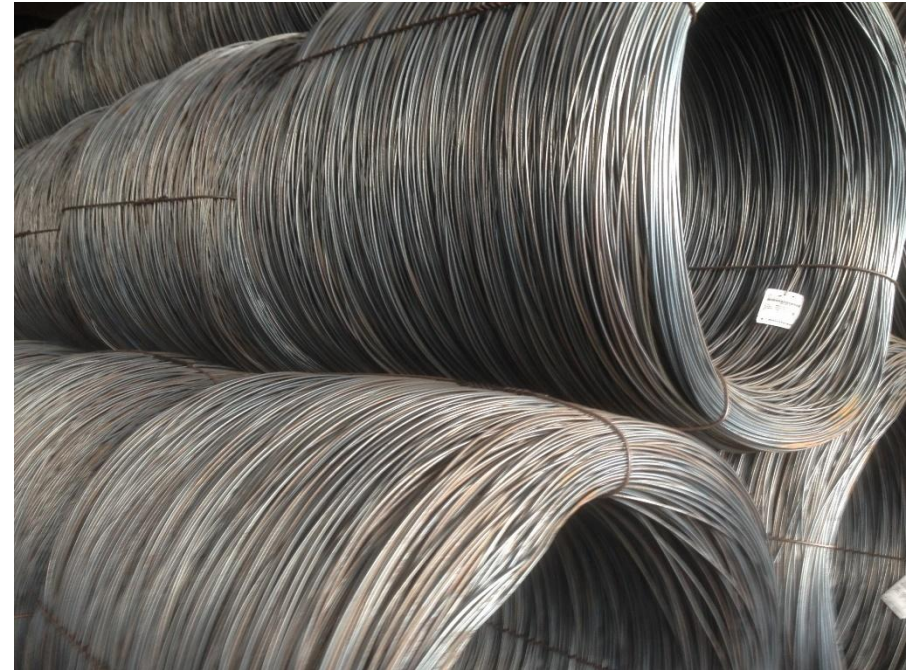
New Laying Head Machine

Good Coil Shaped

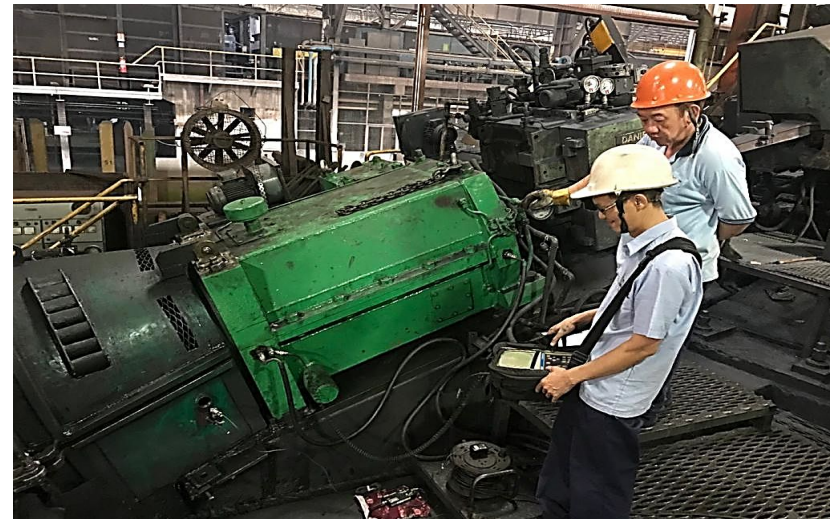
- Preliminary installation in Dec 2017 to matching with existing foundation footing
- All proper procedures were followed in the installation job, and *positive results had been obtained.*

- The Laying Head machine installed according to the schedule.
- The new gear and shaft were assembly properly & fix to new structure.
- Test & commissioning done in Jan 2018 *Checking on Vibration Level in acceptable range*

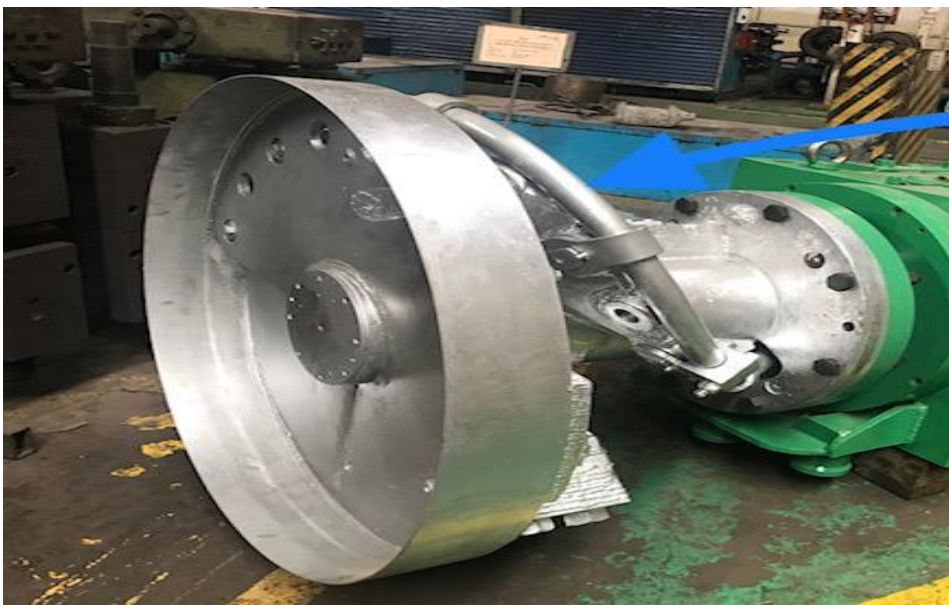
Established SOP

- For clearer & proper installation
- Standardized locking torque on tightening U bracket & half bracket
