IMS MESSSYSTEME GmbH
World Market Leader in Measuring Systems

IDS - Inclusion Detection System

Complete inspection for non-magnetic inclusions and impurities

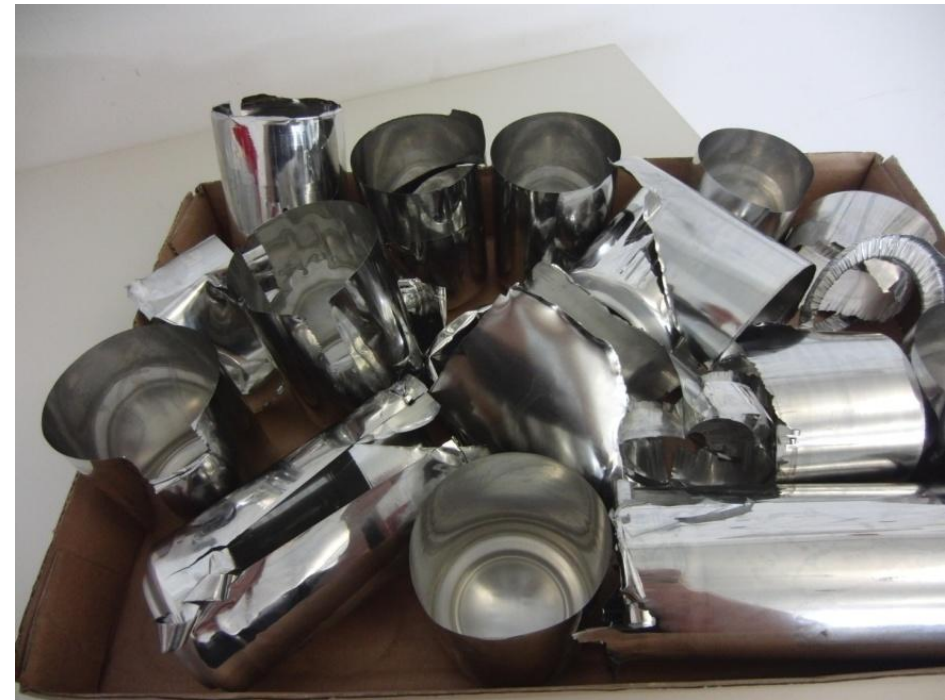
- Tin plate can contain non-metallic impurities like inclusions and segregations
- NMIs can cause problems during the further processing, especially during deformation
- May lead to ruptures in applications involving high deformation ratios, e.g., beverage cans
- Inclusions are sub-surface and cannot be detected by optical inspection

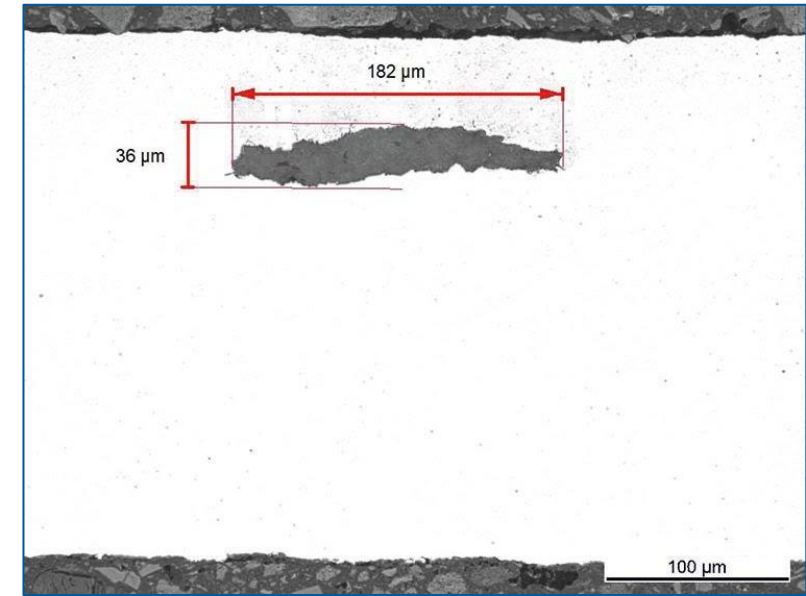
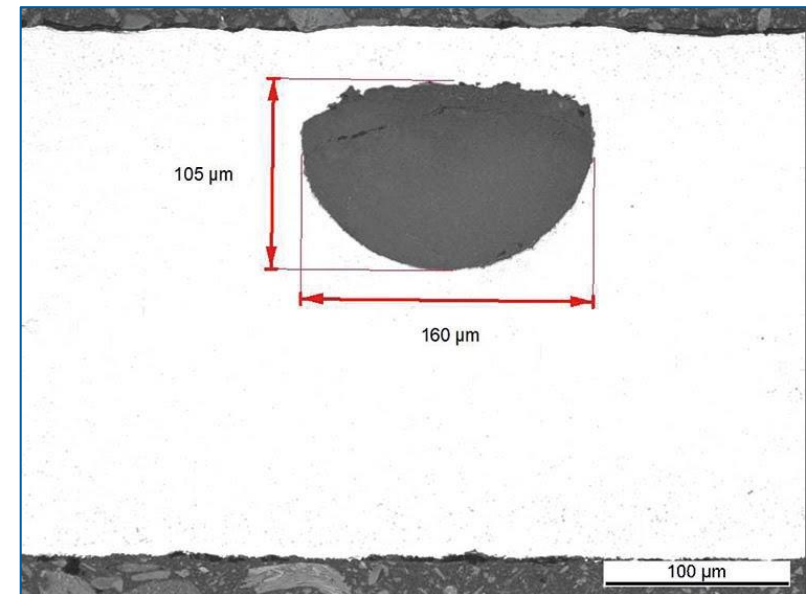
- Mostly oxides of metals like calcium or aluminum
- Deformation by rolling into elongated shapes
- Typical default defect: Inclusion with 1 mm length, 100 μm width and 10 μm length

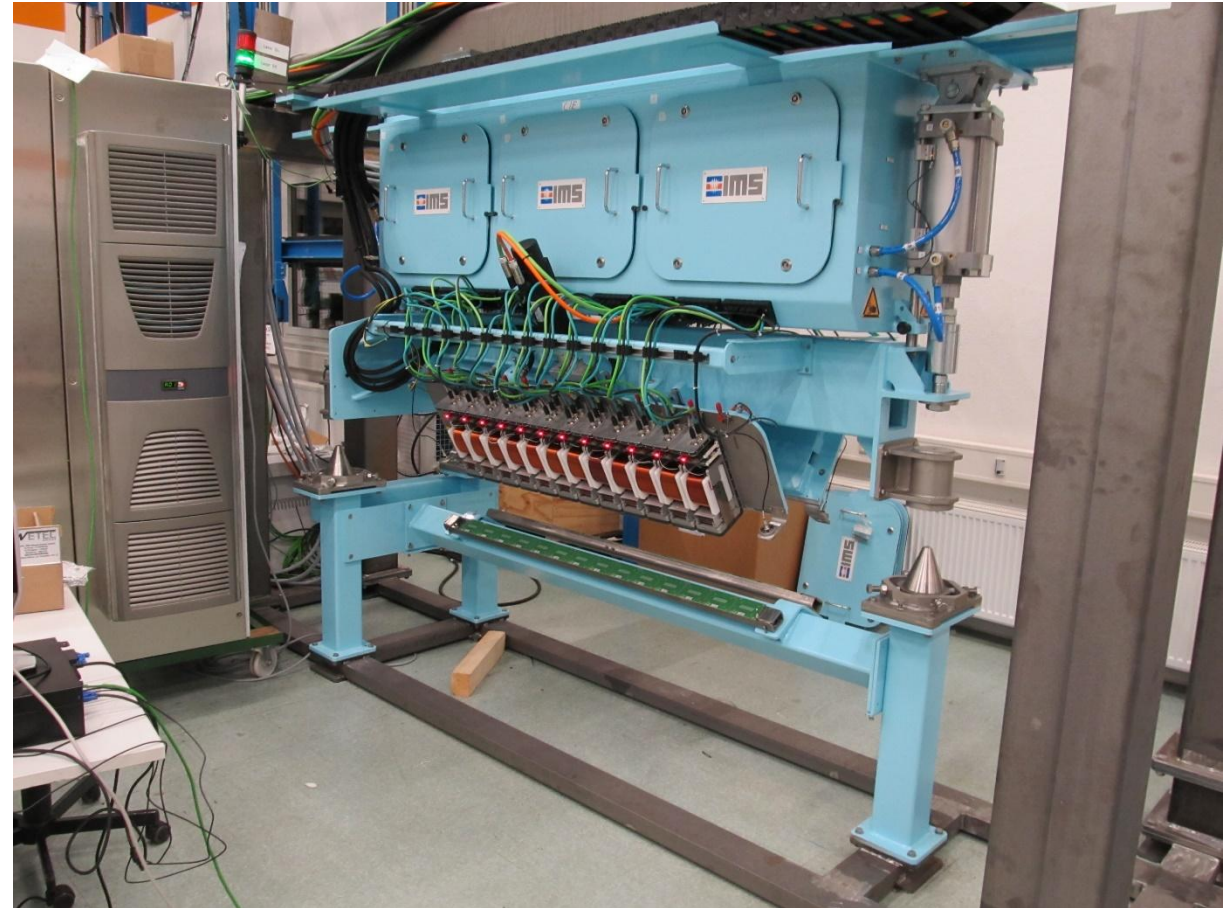
- IMS developed an online inspection system for NMIs based on magnetic flux leakage
- Sensors are incorporated into a compact device acting as a MFL line camera
- Can be combined in different configurations, enabling a gap-free coverage of inspected strip

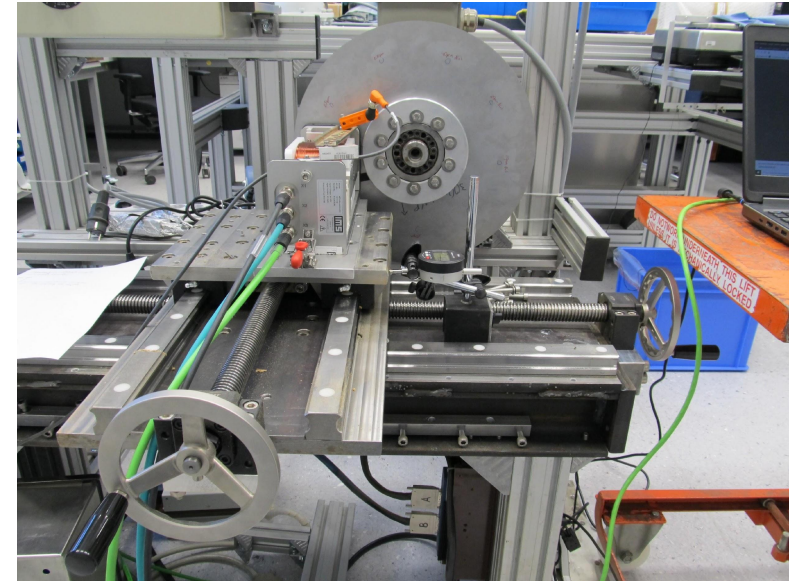
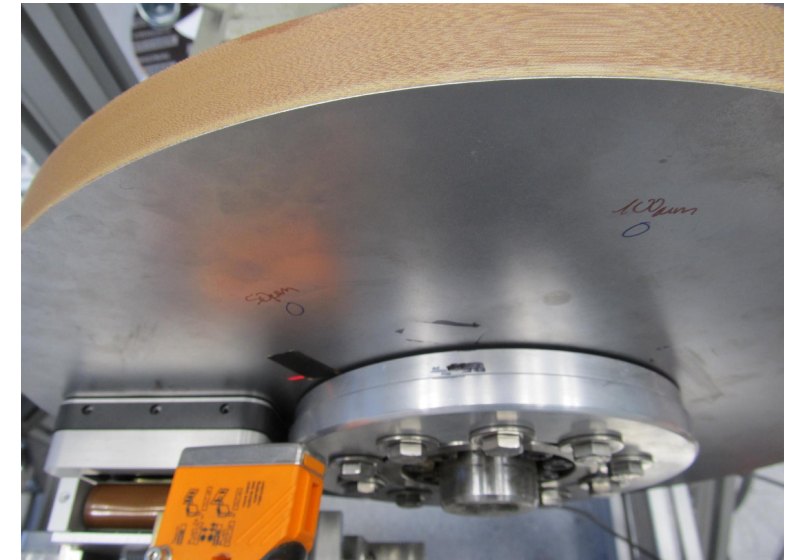
Laboratory Setup

- Material speed simulation is implemented by fixing round plate samples to precisely faced discs
- The discs are rotated by a VFD-controlled motor
- A cross table is placed in front of the discs surface for precise sensor placement
- Customer samples with natural or artificial defects can be examined

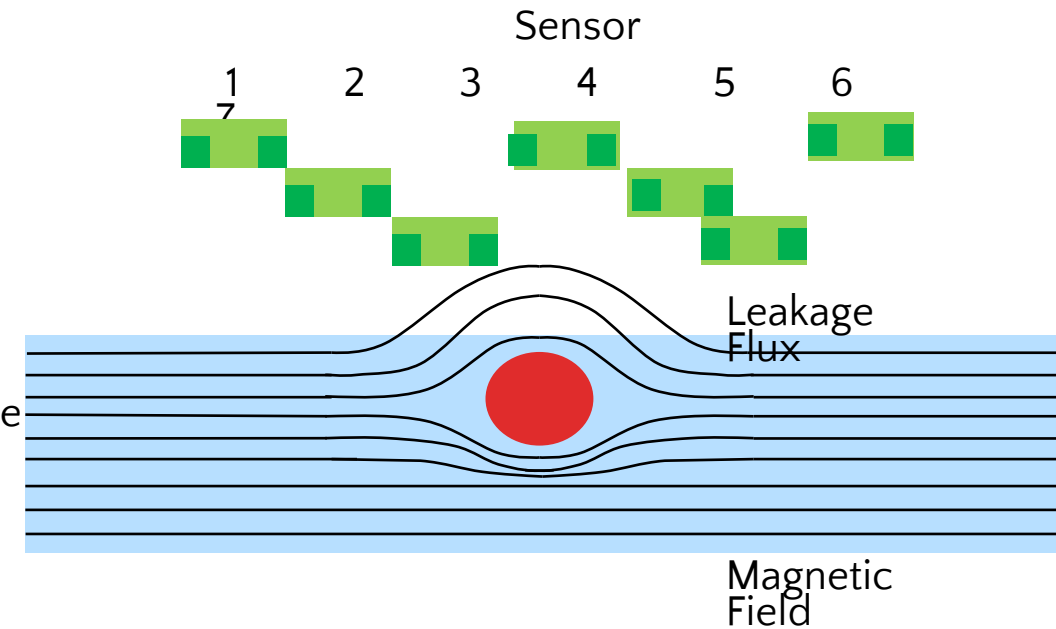
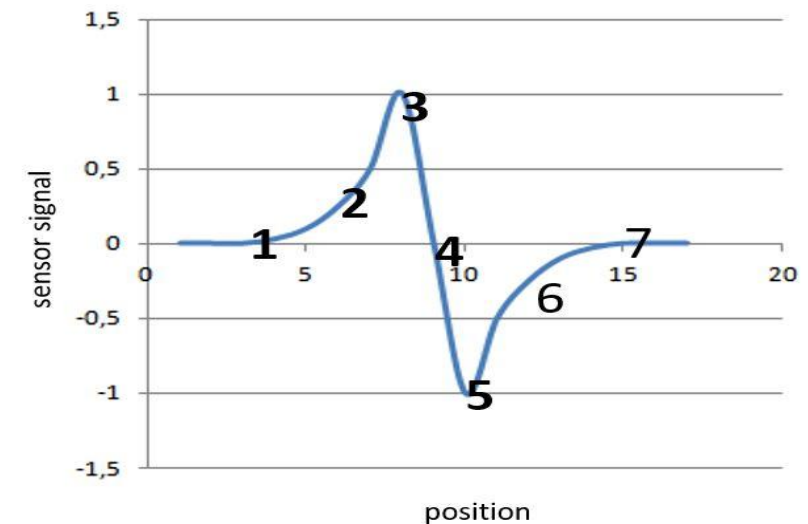
Magnetic flux leakage

- Variation in the magnetic cross-section of a magnetically saturated material causes a flux variation on its surface
- Most defects are non-magnetic, making this approach suitable
- MFL is widely used in form of magnetic powder testing
- IMS Messsysteme developed a measuring system based on GMR-Sensors, enabling complete online MFL inspection
- Compared to similar systems, the liftoff to the inspected material is increased making the system less vulnerable, while sensitivity is improved

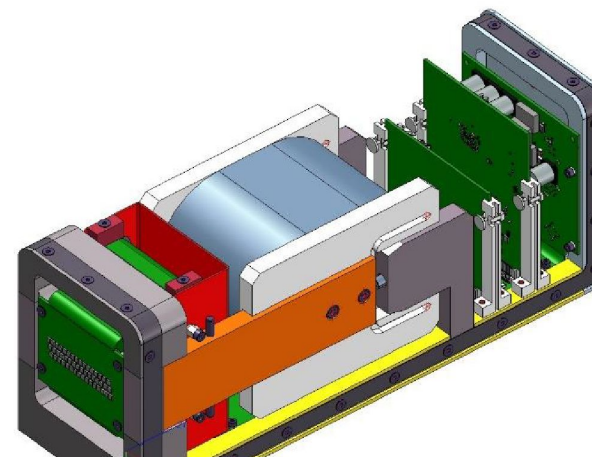
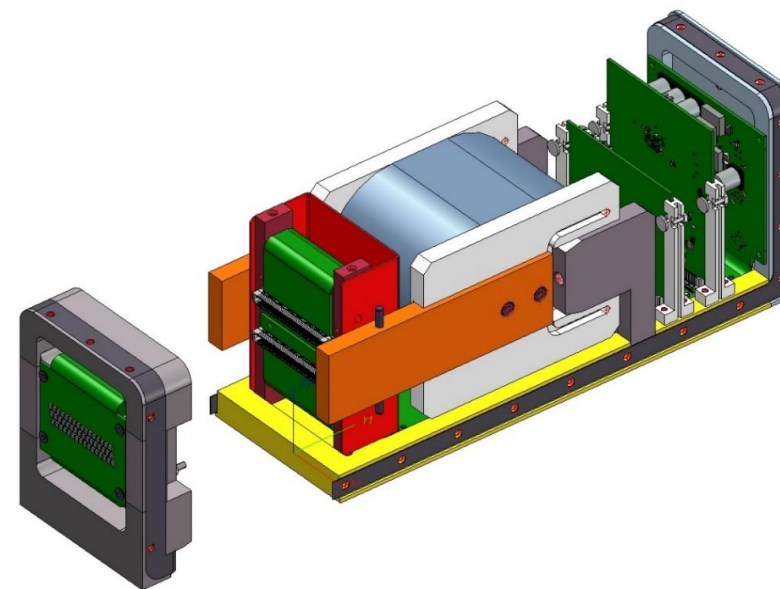
Sensor Modules

- 48 GMR-Sensors in one sensor module
- Spatial resolution is 1 mm
- Total width of a module is 95 mm
- 2 lines of modules are sufficient for full coverage
- Variable sampling rate of up to 200 kSa/s, sufficient for 1000 m/min strip speed
- Protected sensor block, easily exchangeable in case of damage

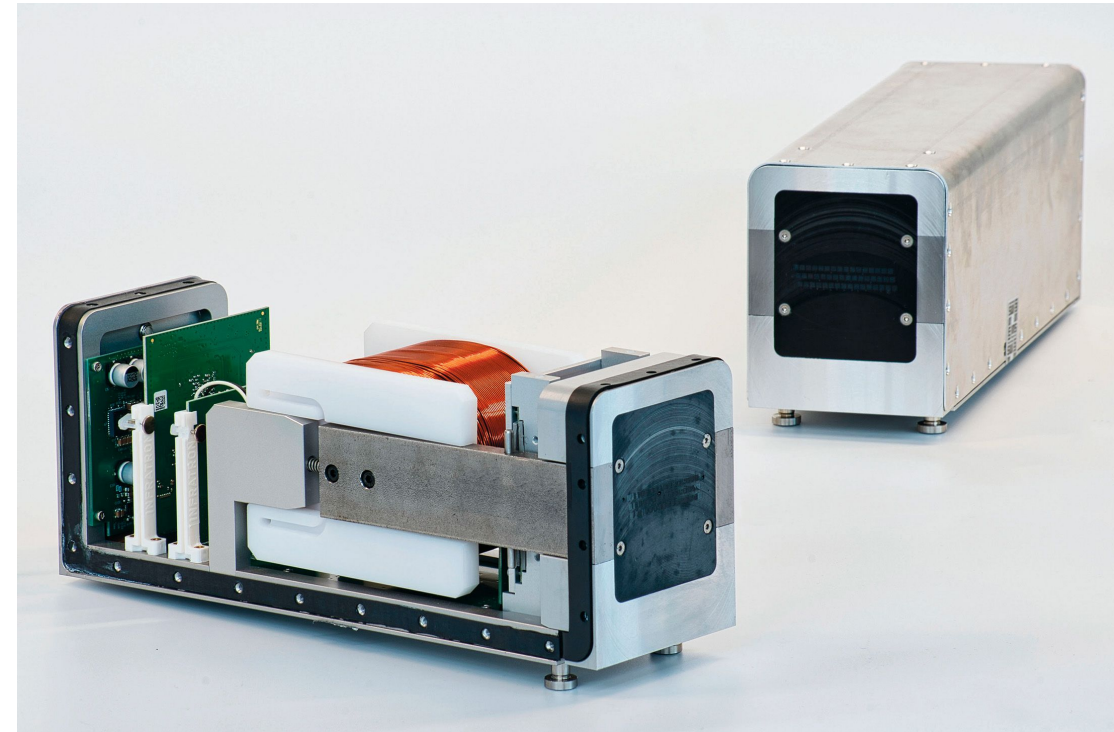
Sensor Modules

- Protected sensor block, easily exchangeable
- No mechanical adjustment needed after change
- Magnet can be turned off for cleaning and safe maintenance
- Dust- and spray-water-proof

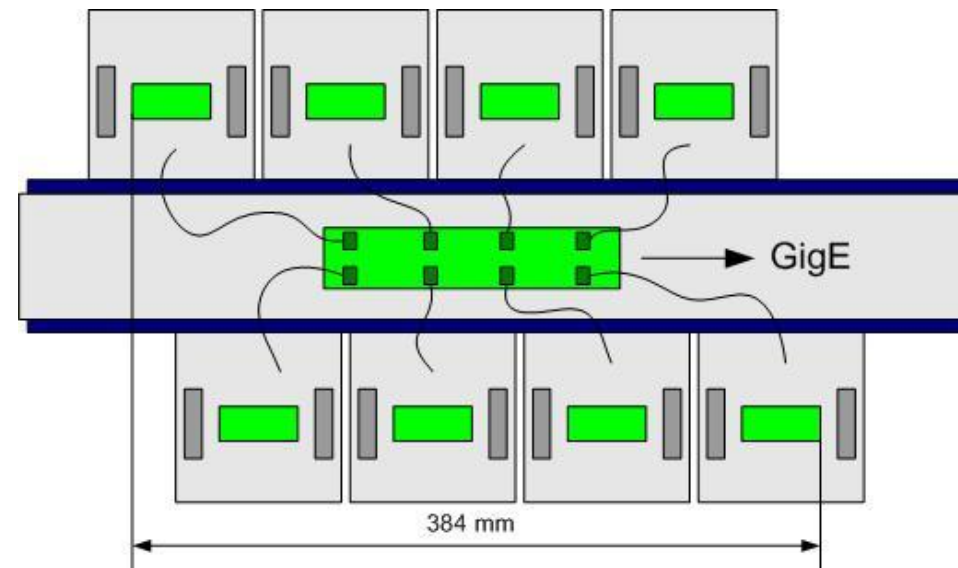
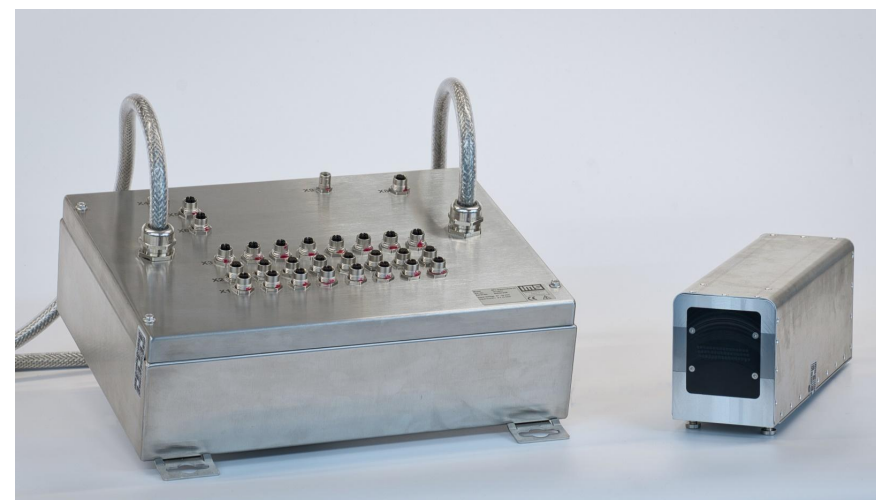
Aggregator Hub

- Sensor modules arranged in two rows
- Max. 8 modules are combined to one group
- Each group covers a width of 384 mm
- Each group represents a MFL Line Scan Camera with GigE connection
- Min. 20 mm/max. 65 mm. at both strip edges are not covered by sensors

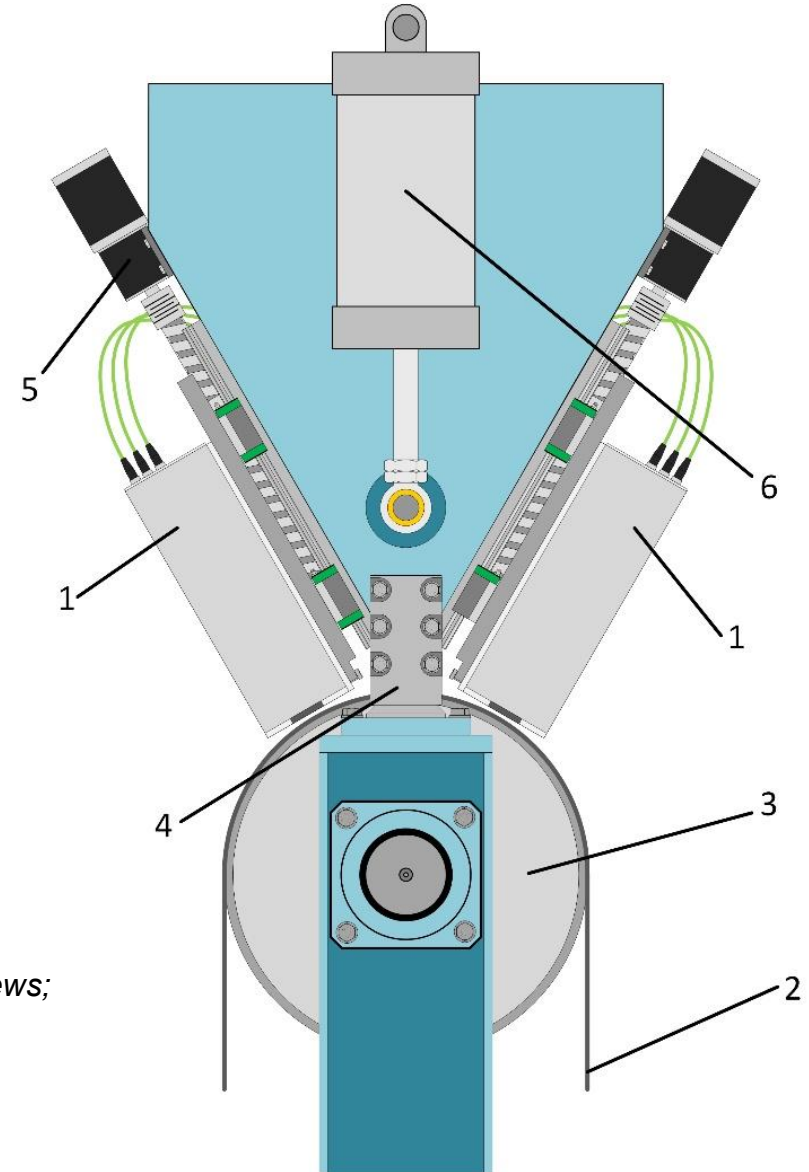
Contact-Less Inclusion Detection

- Installation on roll – close to the surface but without contact
- Precise liftoff adjustment by ball screws and servo drives
- Adapts to variable material thickness
- Liftoff is controlled by capacitive sensors
- Fast pneumatic retraction to prevent collisions

*1: sensor modules; 2: measured strip;
3: support roll; 4: pilot pin;
5: fine adjustment with servo drives and ball screws;
6: fast retraction by pneumatic cylinders*

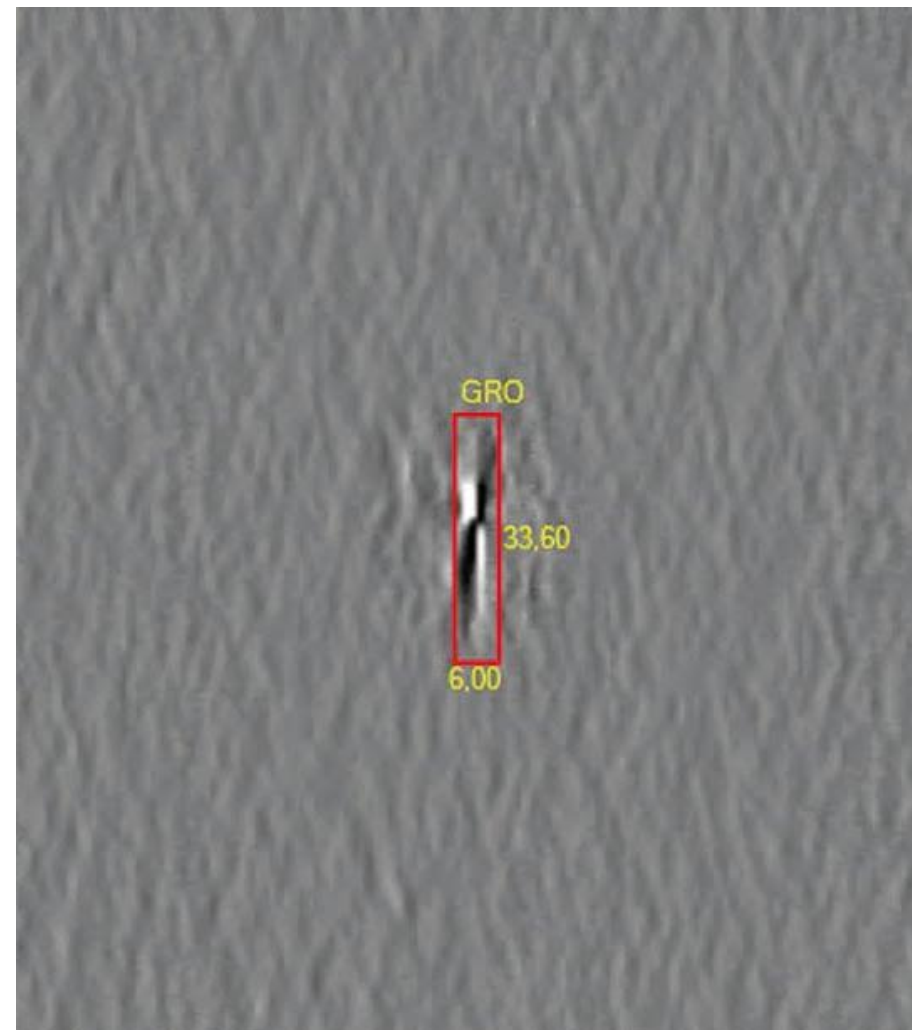
MFL – Line Scan Camera

- Sensor output is recorded along the length of the strip
- Result can be interpreted as line scan image
- Exemplary image of a detected defect

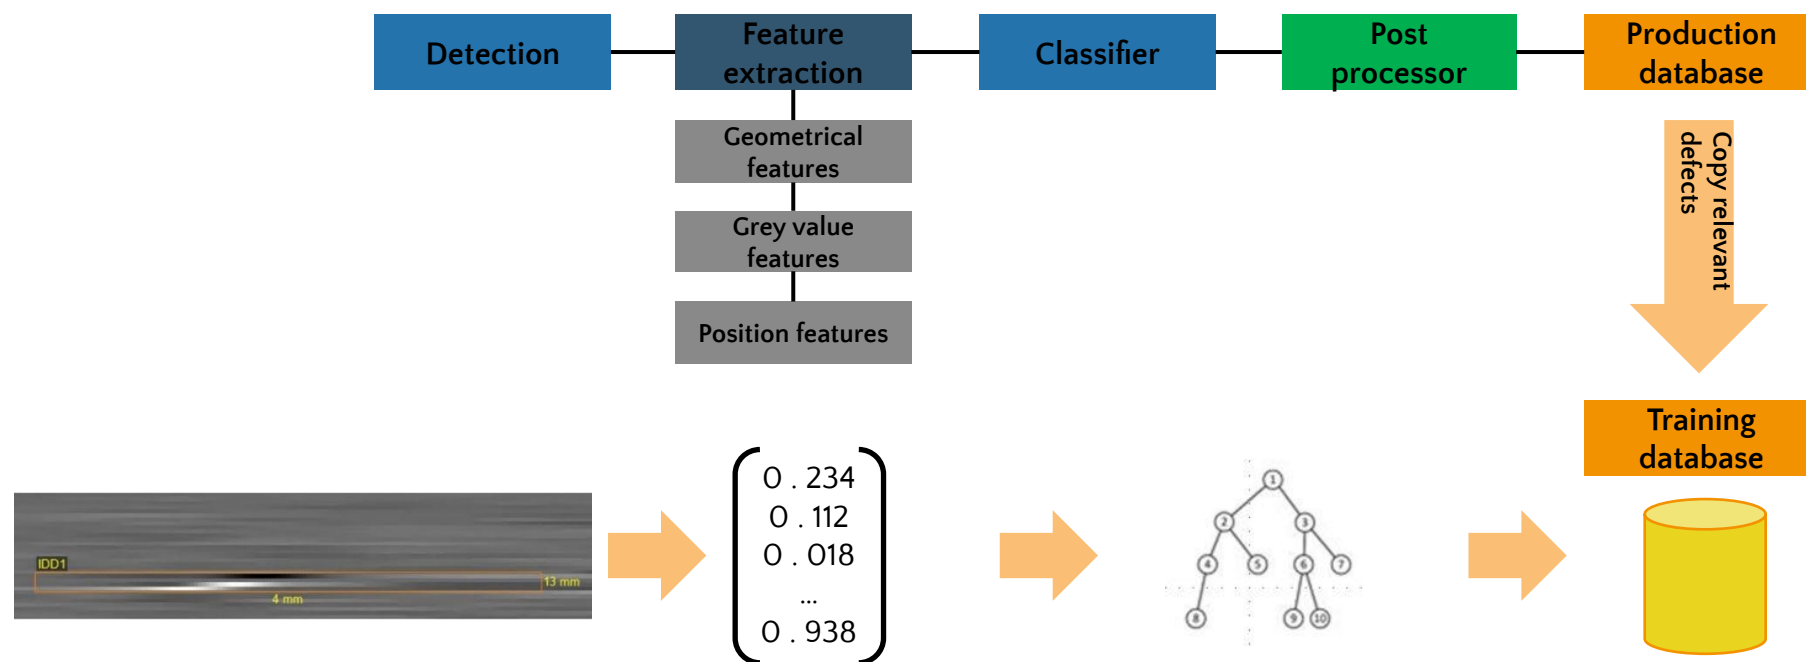
MFL – Line Scan Camera

- Images are evaluated by the IMS surface inspection software
- IDS uses all the features of IMS inspection technology - developed for surface inspection systems

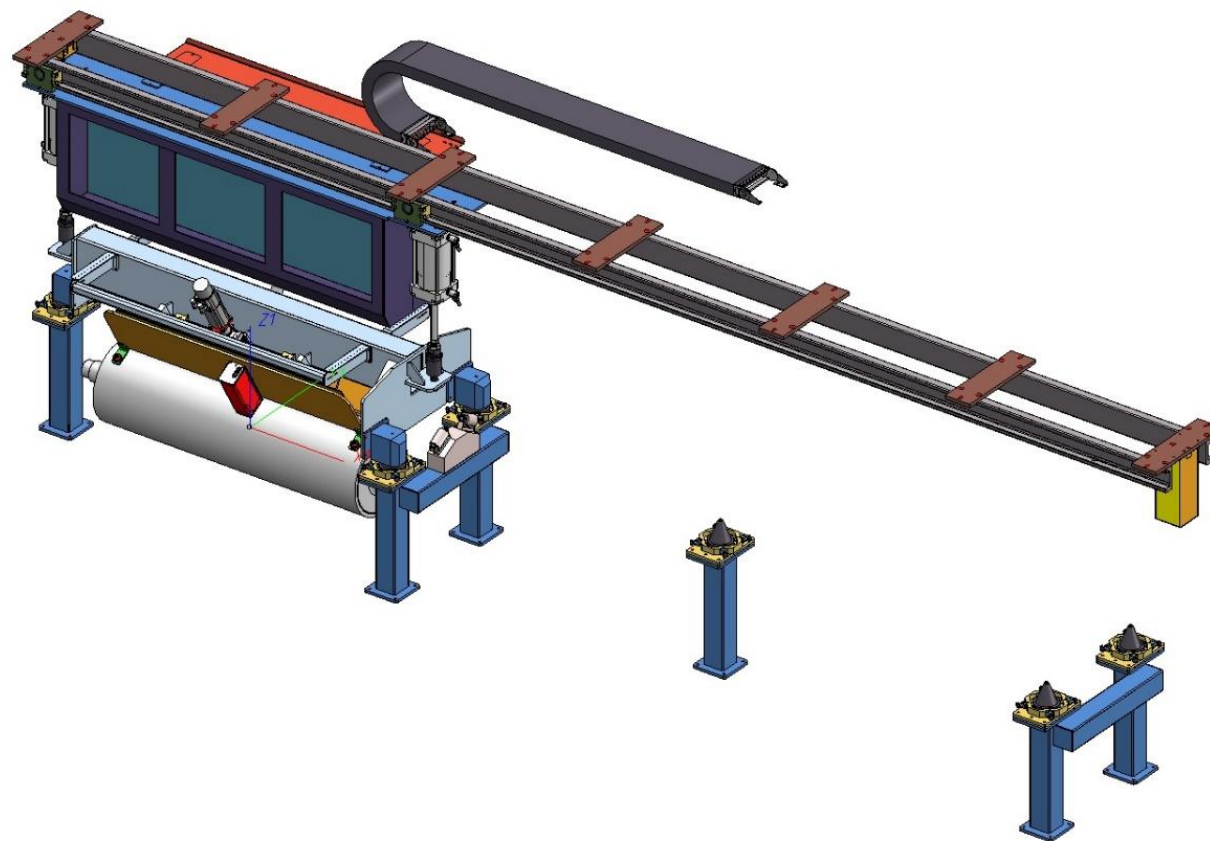
Easy Maintenance

- System can be completely driven out of line for maintenance
- Features automatic cleaning
- In park position, all sensors are automatically equalized
- Easy module mounting and dismounting

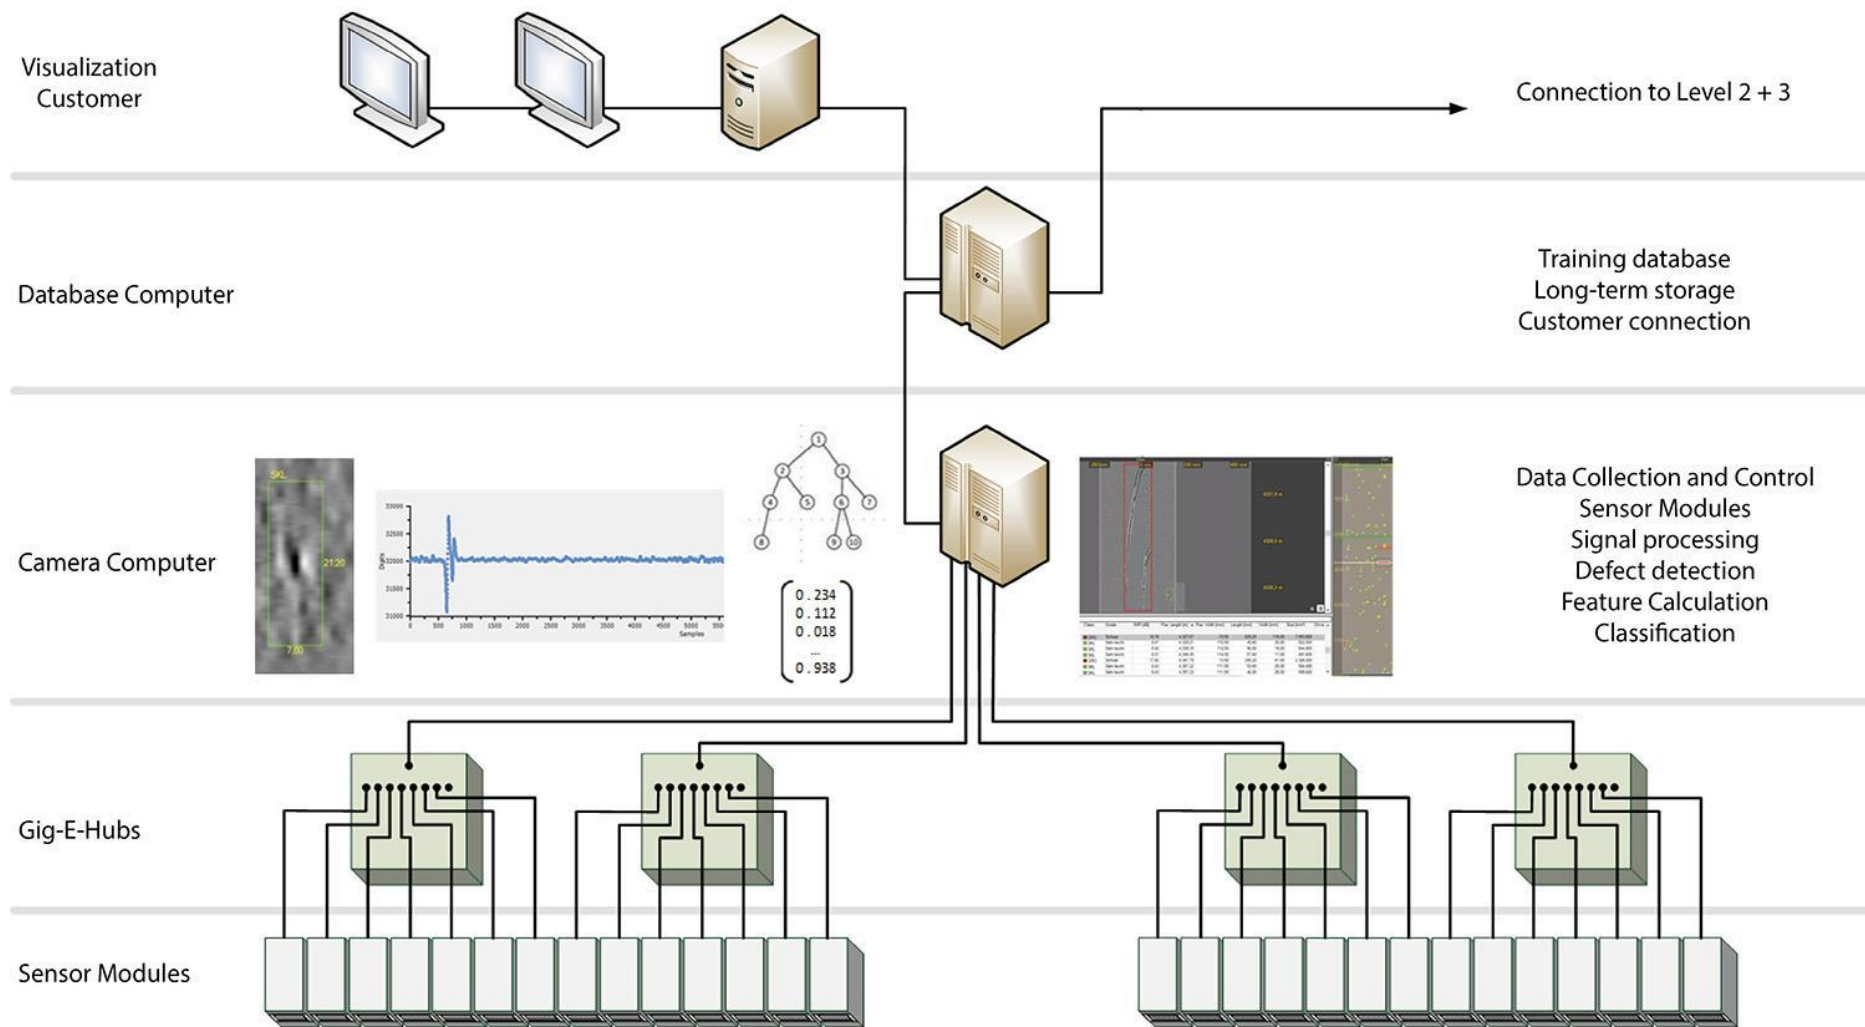
Fully Integrated Online System

Material	Cold Rolled Ferromagnetic Steel
Thickness	0,12 – 0,35 mm (Tin Plate) 0,3 – 1 mm (Colled Rolled Steel)
Speed	10 m/s
Defect Size (LxWxH)	1 mm x 100 µm x 10 µm
Liftoff	app. 0,5 mm
NIMI Material	Air SiO ₂ AL ₂ O ₃ AL ₂ O ₃ CaO
Roughness	Ra < 1,5 µm

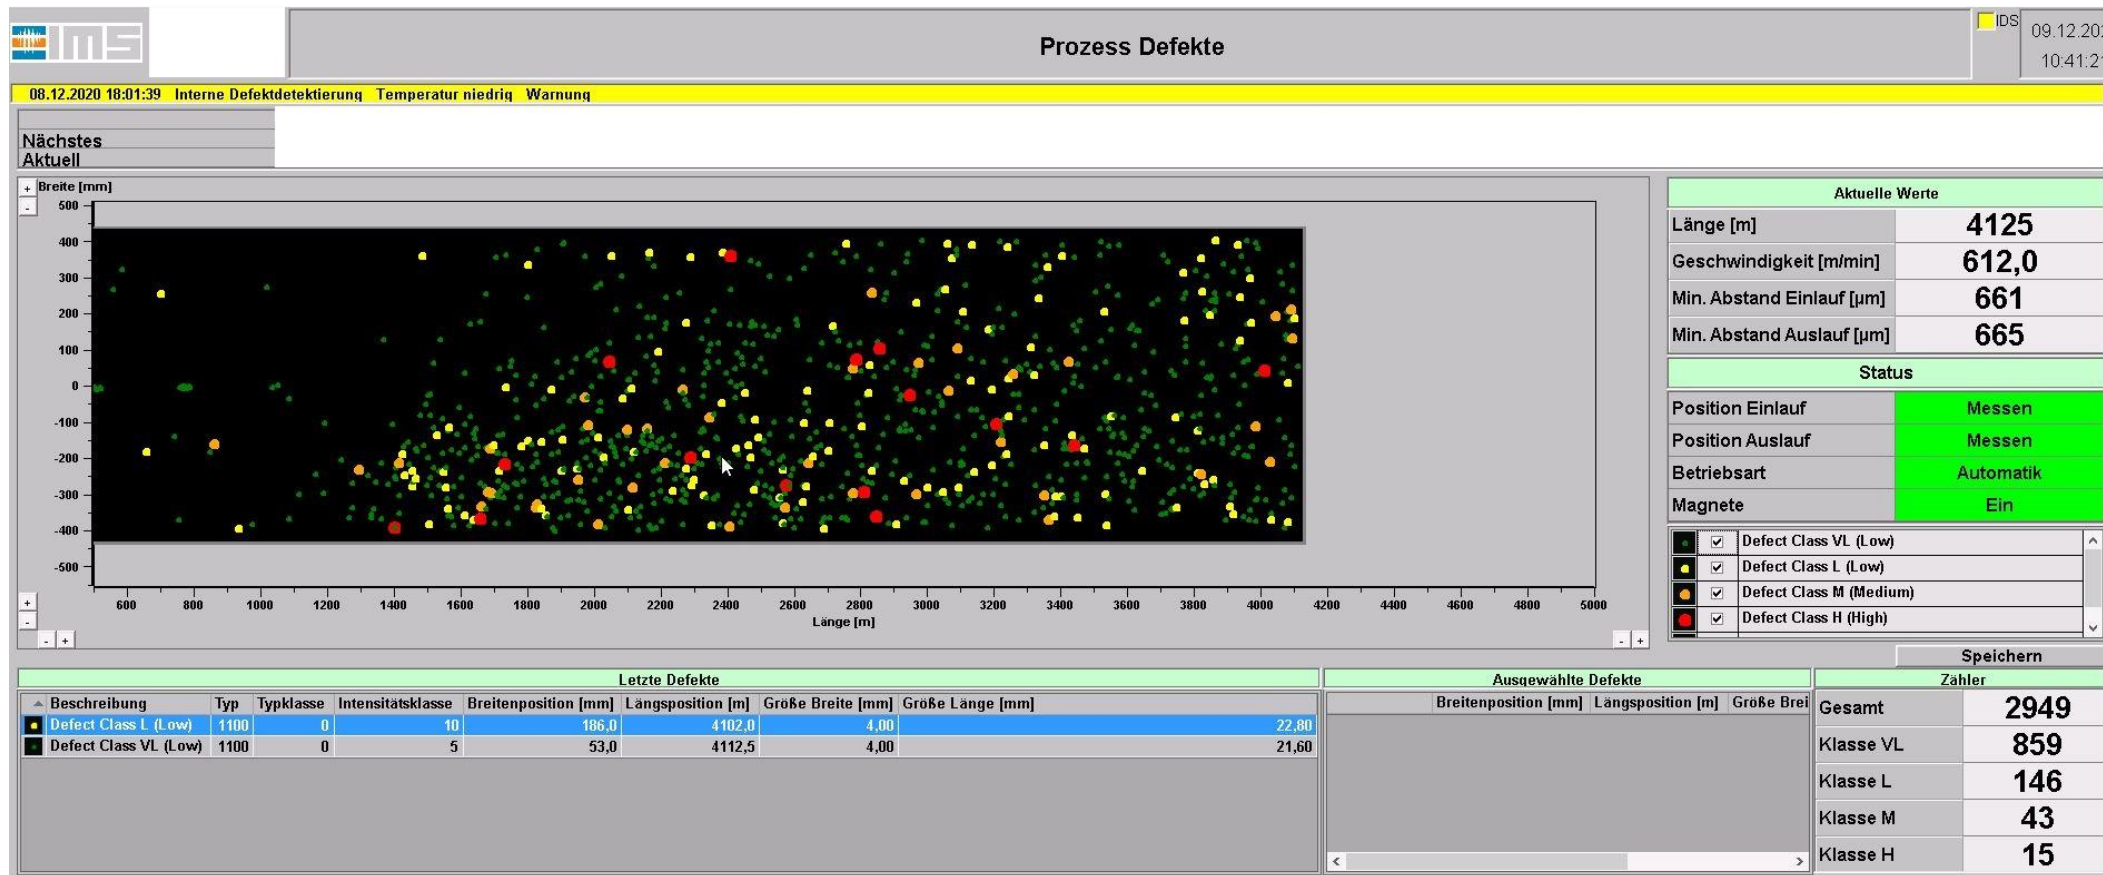
Online Result

Sample: Small defect, increasing defect density

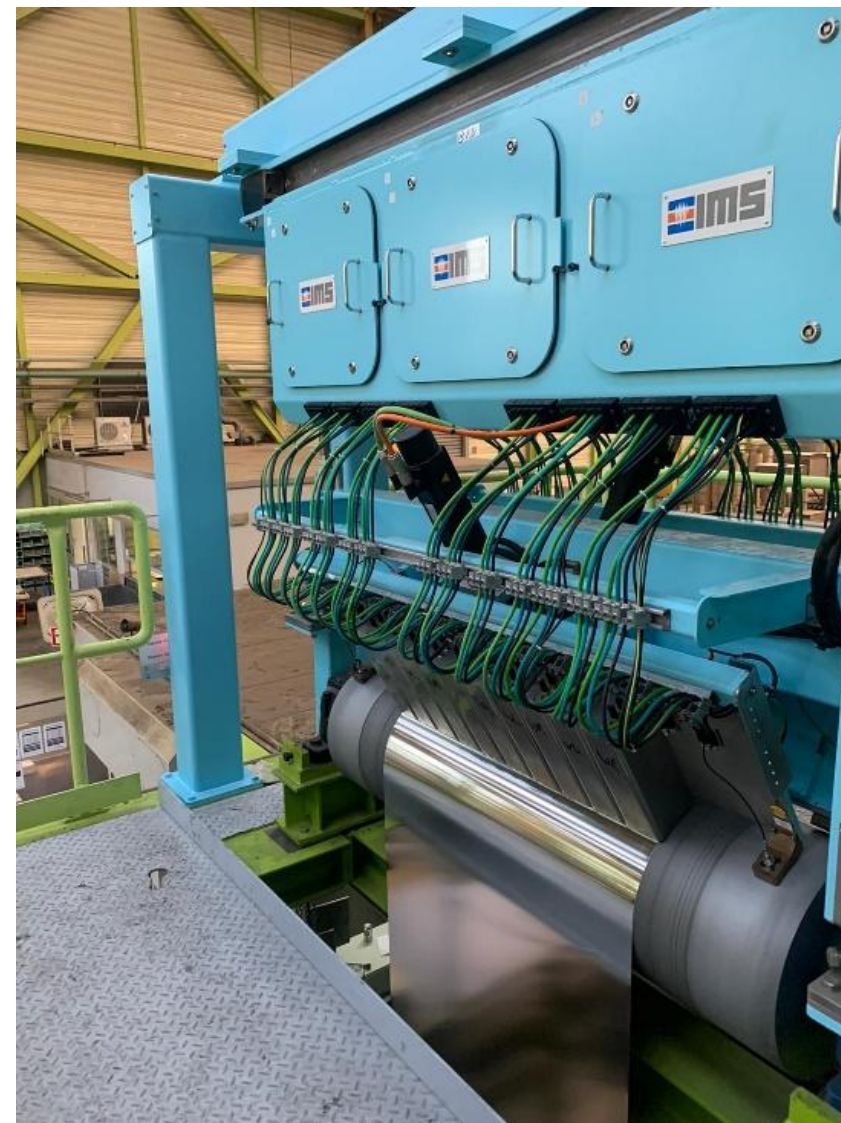
IDS Installations

- First system was be installed in 2019
- Contains 28 sensor modules
- Follow up system with 34 sensor modules was installed in 2021
- Next installation will be test in CGL in 2023
